# Newsletter of **Environmental, Disaster, and Crises Management Strategies**

Issue No.12 | December 2018

## **The December 2018 volcano-triggered tsunami in Krakatau complex (Sunda Strait, Indonesia)**

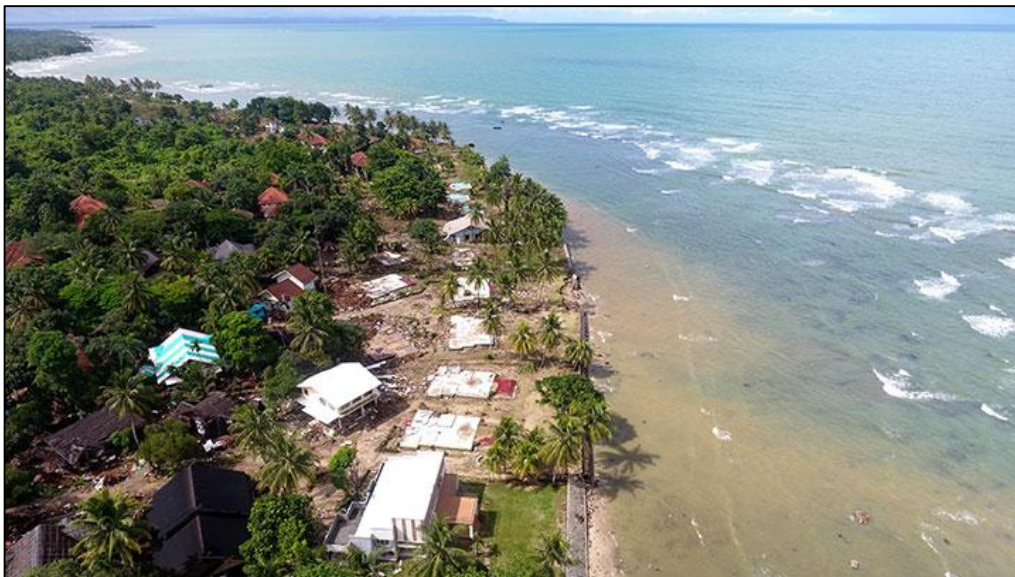
Panoramic view of the shallow coastal area of the western Java in Carita beach. The small depth increased the height of the waves and their devastating power along the coast resulting in severe structural damage in buildings and infrastructures and many fatalities.

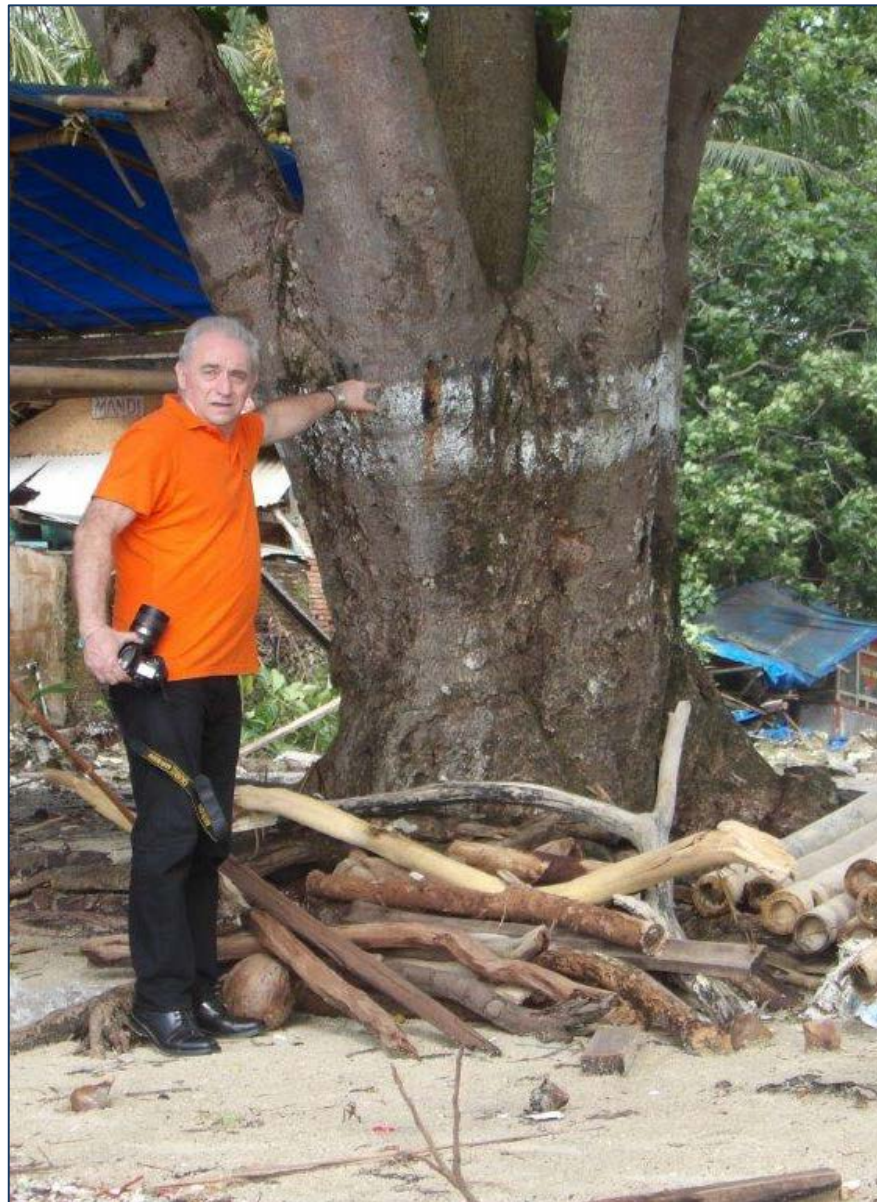
Scars and marks on trees from tsunami in Carita beach (western Java)

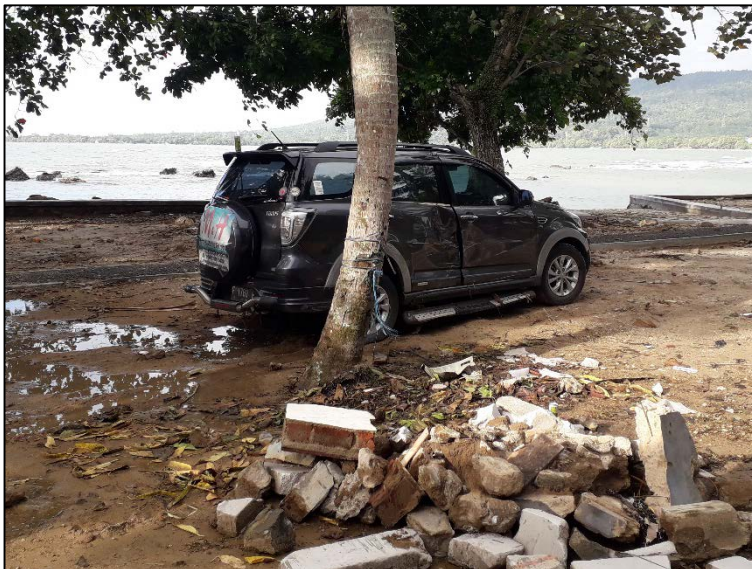
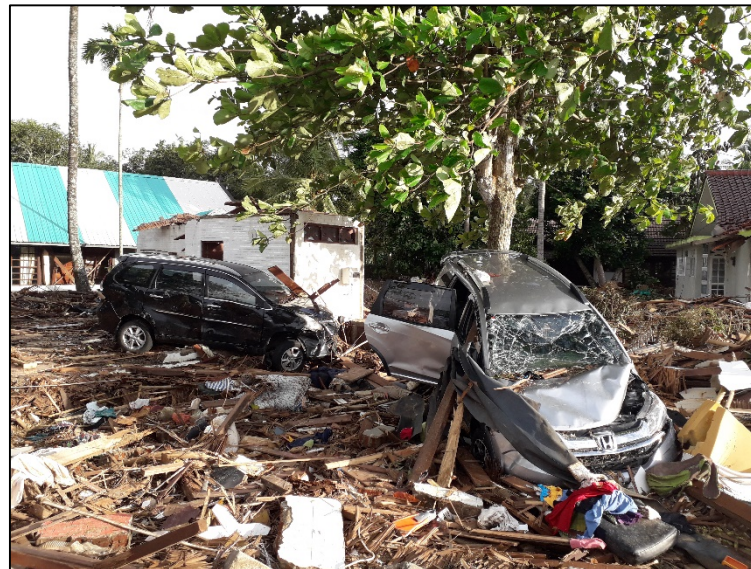
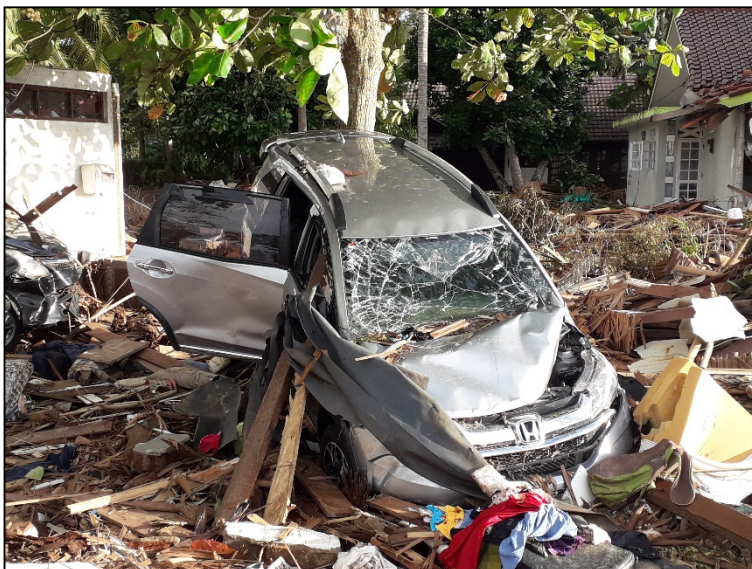
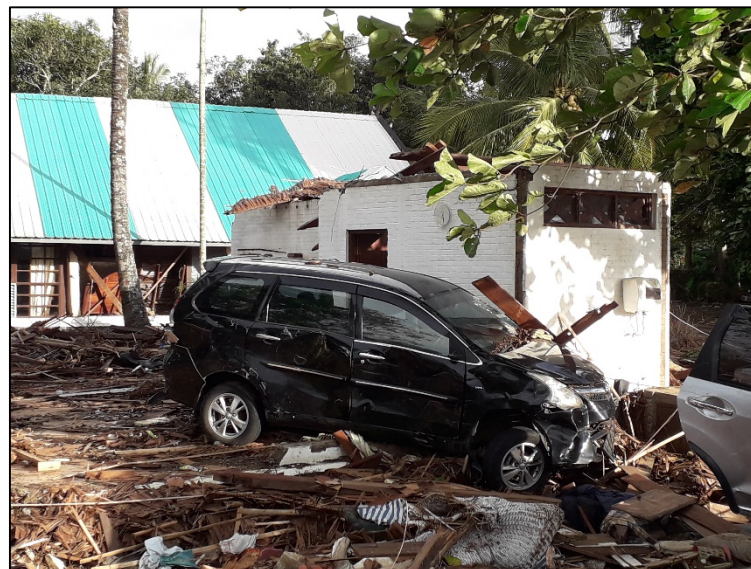
### Cars

## IMPACT OF THE VOLCANO-TRIGGERED TSUNAMI ON MOBILE OBJECTS

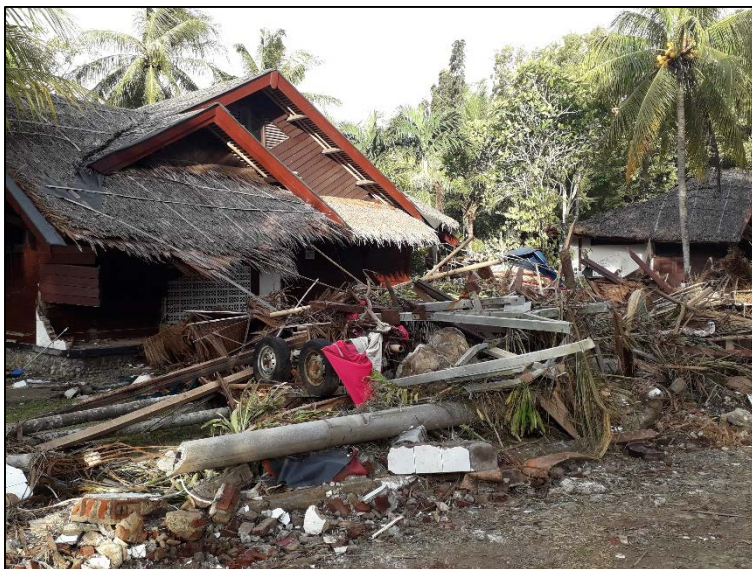
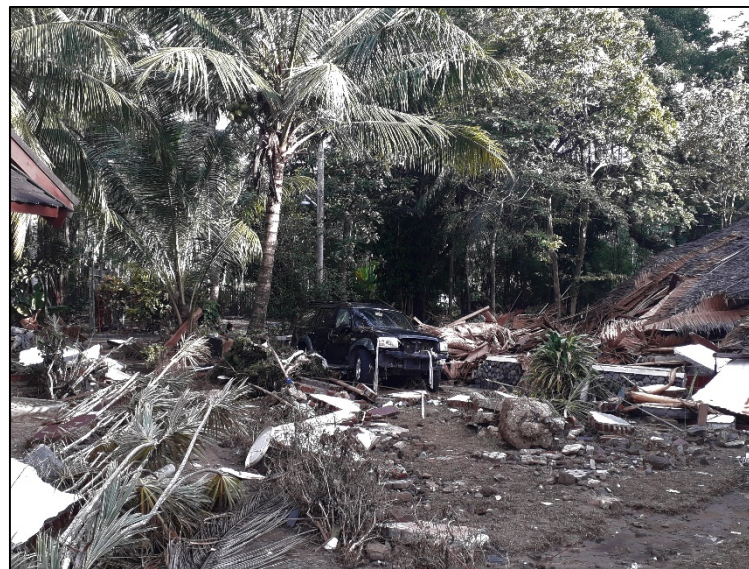
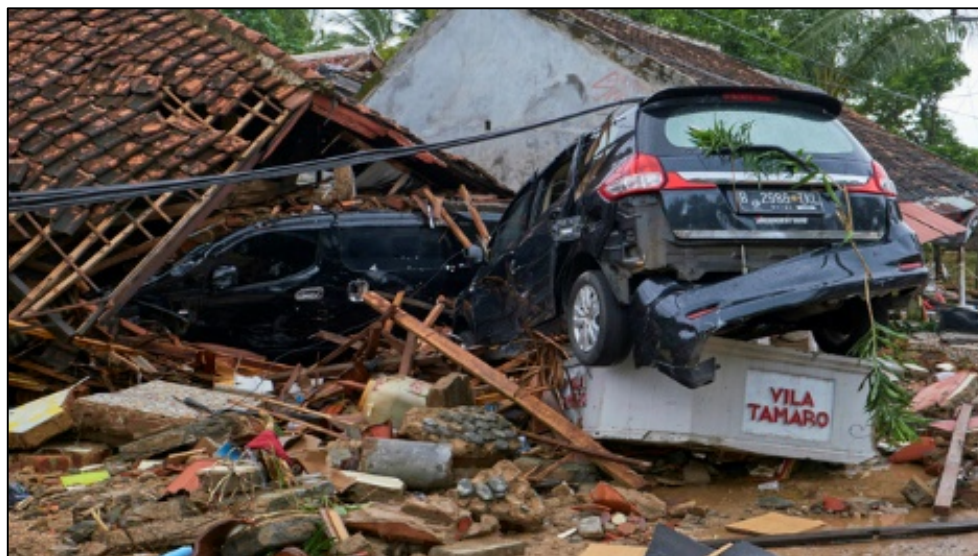
### Cars

## IMPACT OF THE VOLCANO-TRIGGERED TSUNAMI ON MOBILE OBJECTS

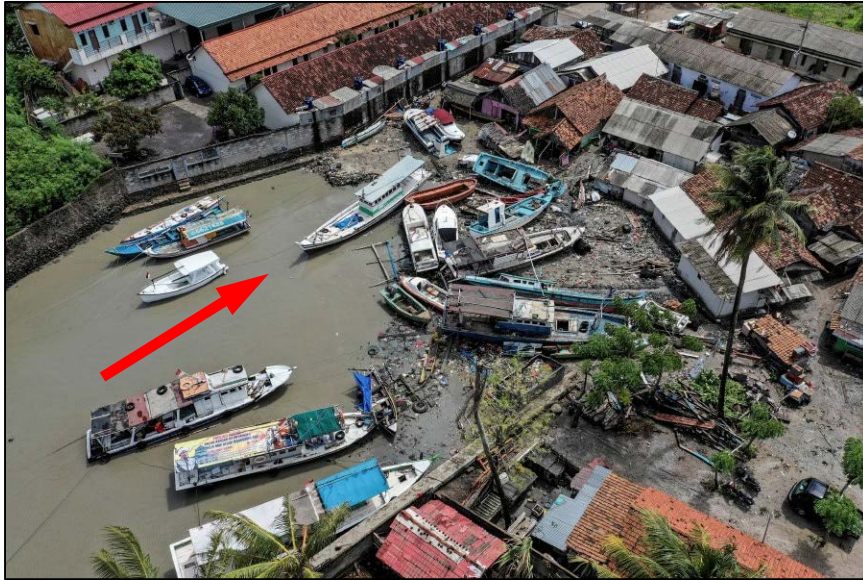
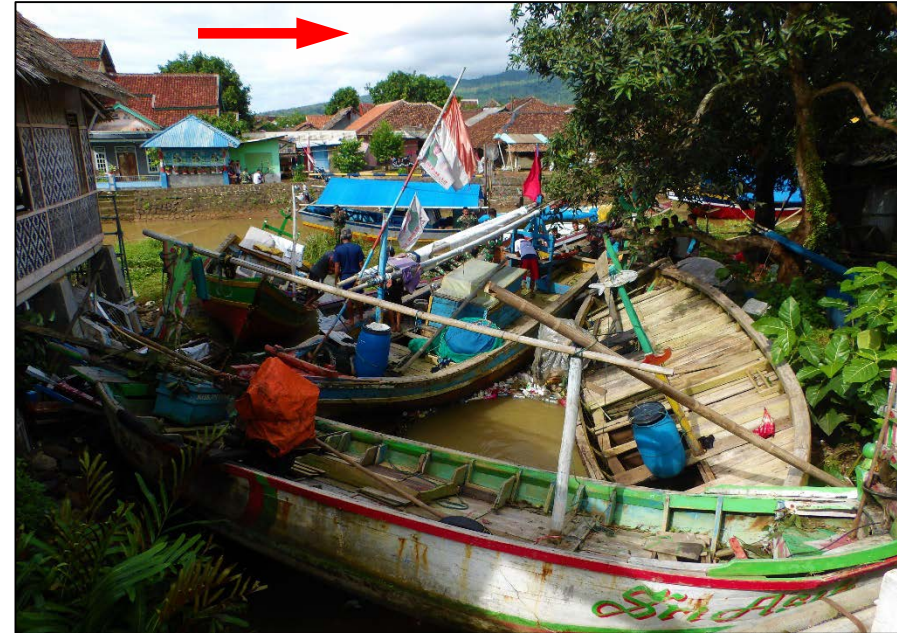
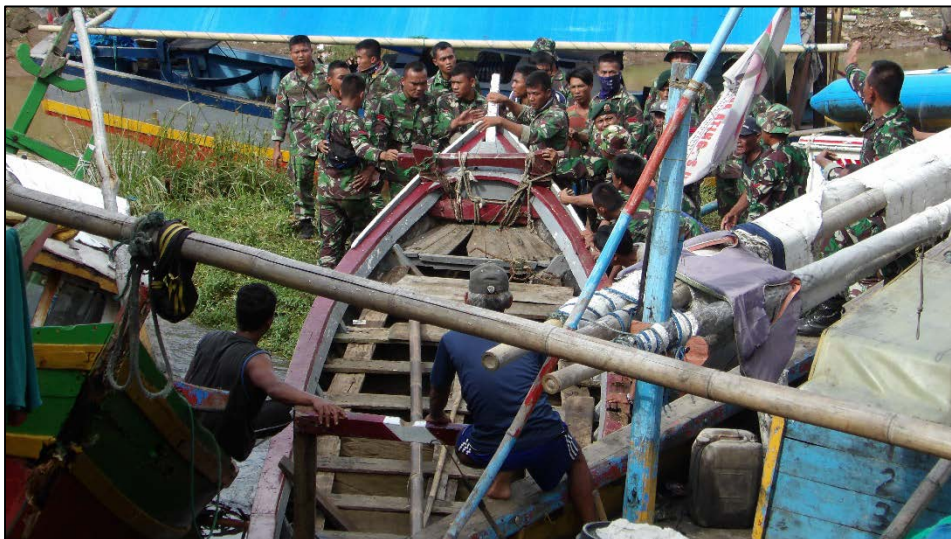
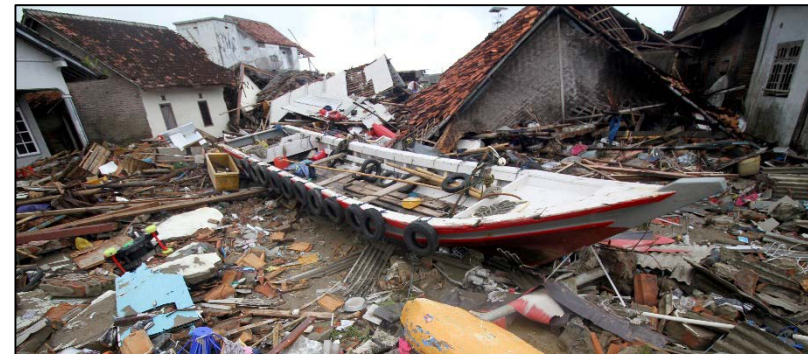
Vessels and boats are washed away, destroyed or moved to higher elevation

→ Arrows indicate direction of tsunami water flow

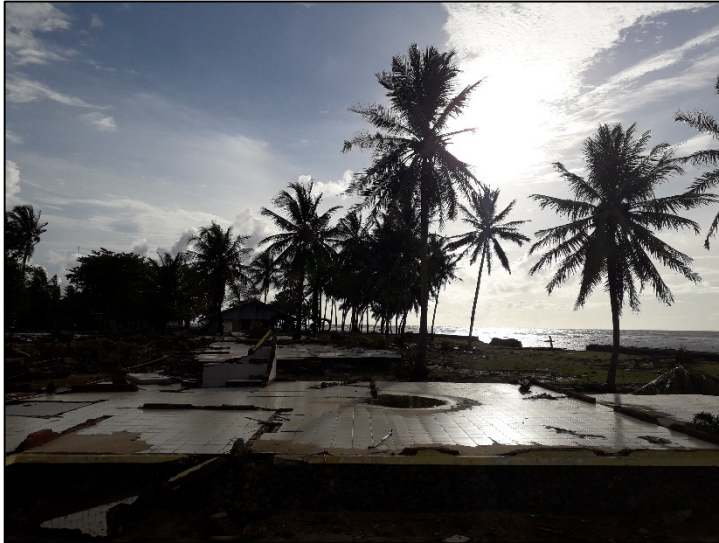
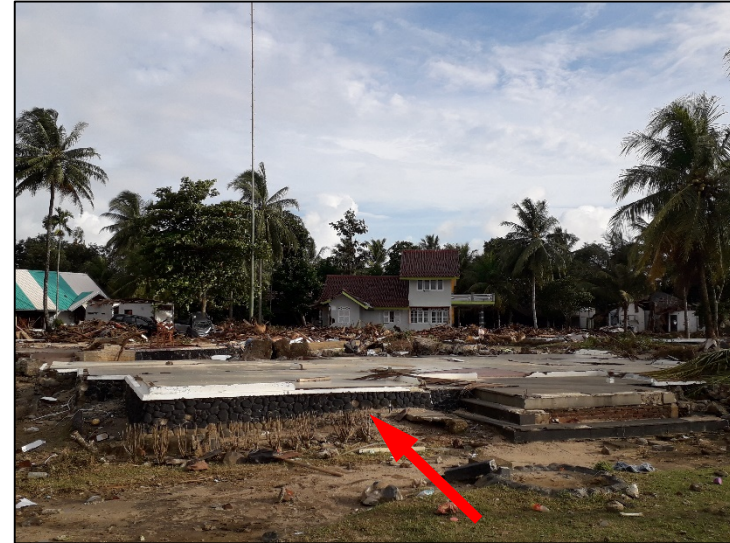
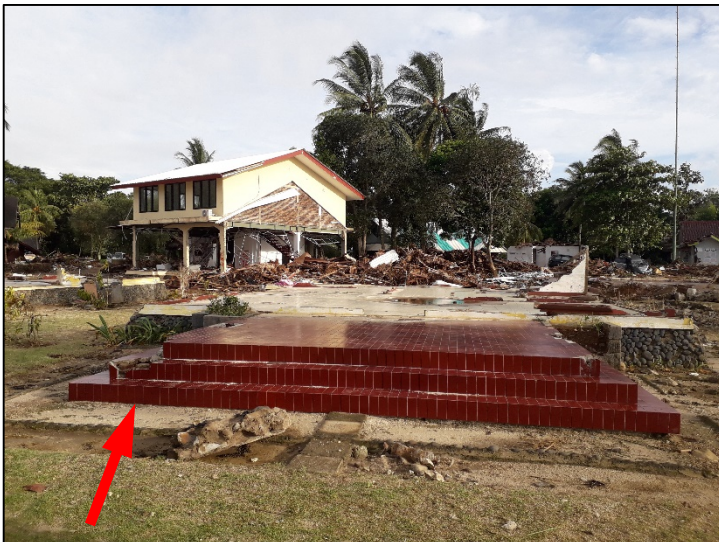
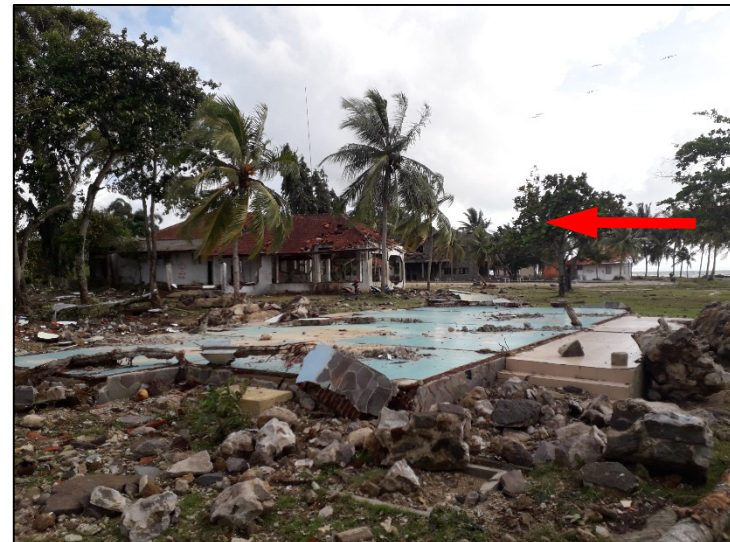
Many wooden houses were swept away within areas struck particularly hard. The tsunami washed away many of them, leaving only their concrete base.

All structures founded along the beach front suffered heavy structural damage. More specifically, the wooden structures were washed away by the tsunami waves.

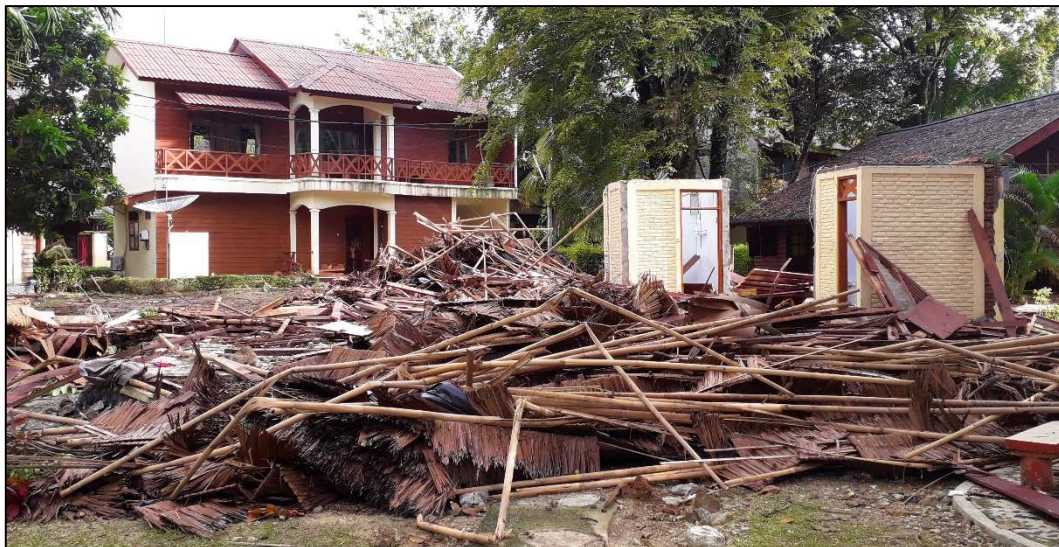
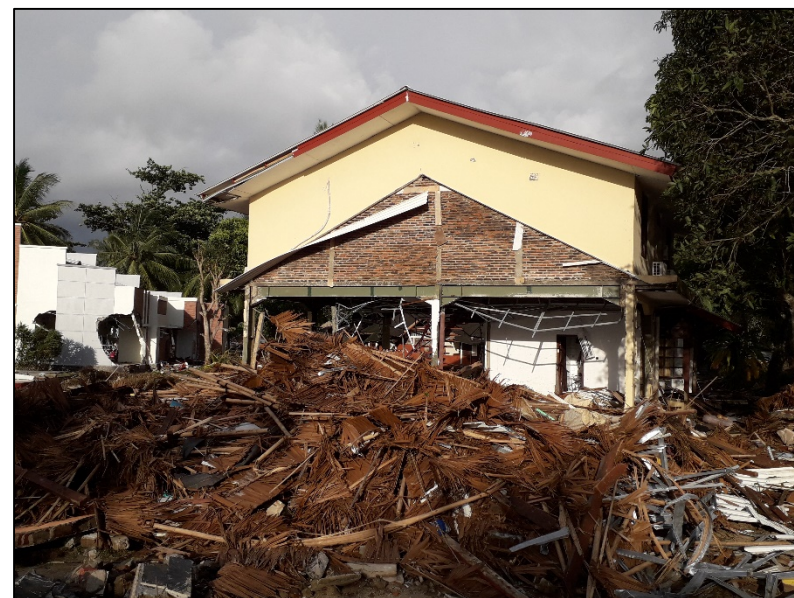
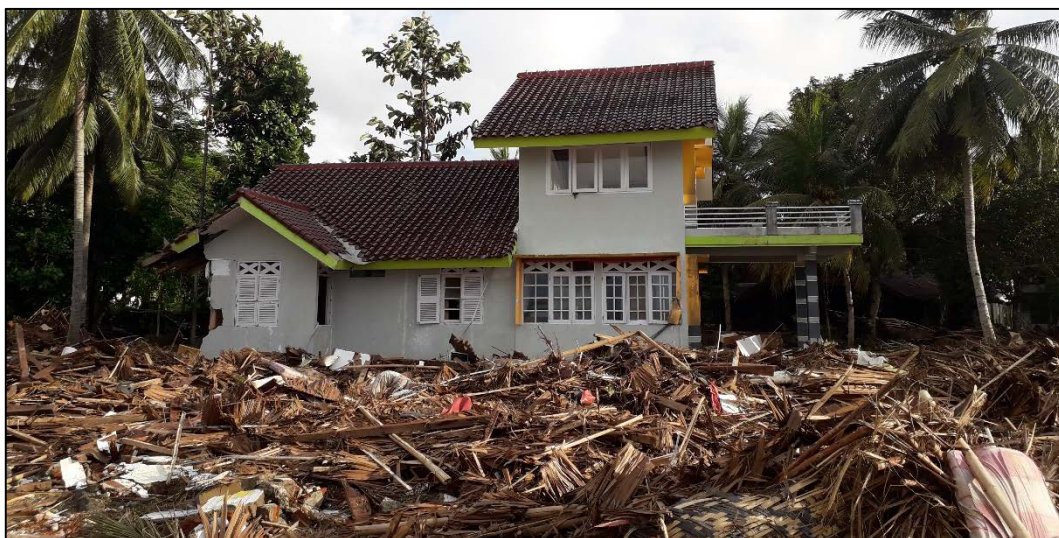
All sea front wooden structures were washed away by the incoming tsunami waves resulting in sites of debris accumulation along the affected coastal area

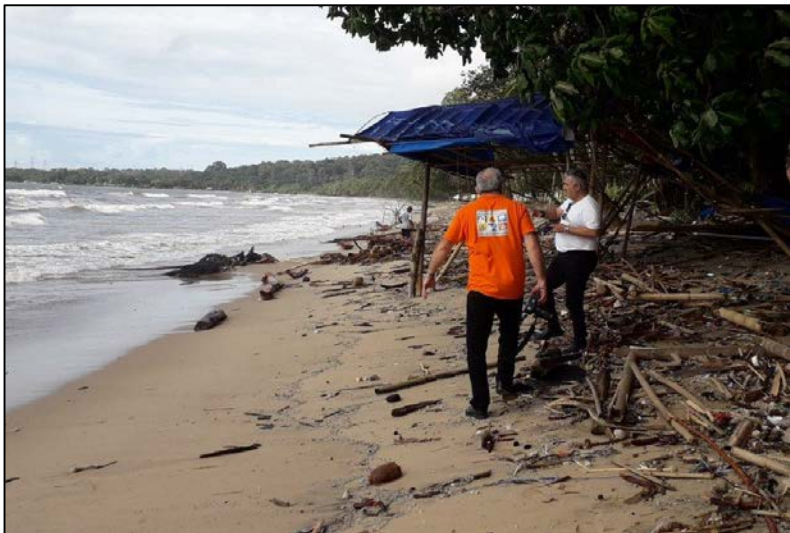
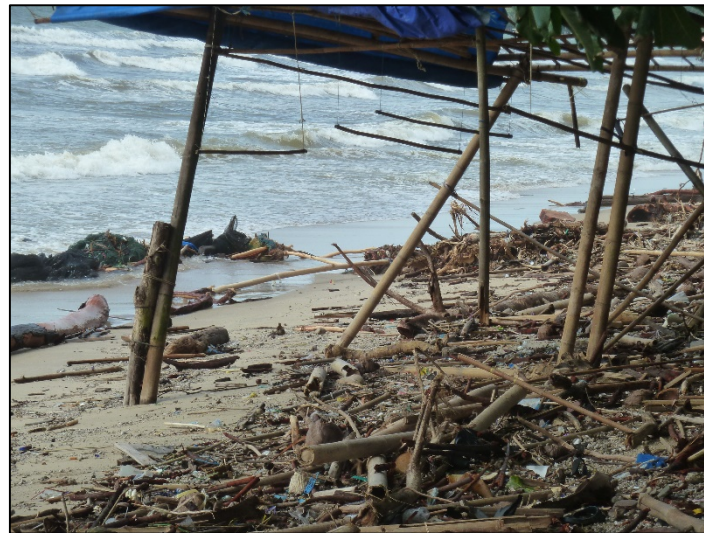
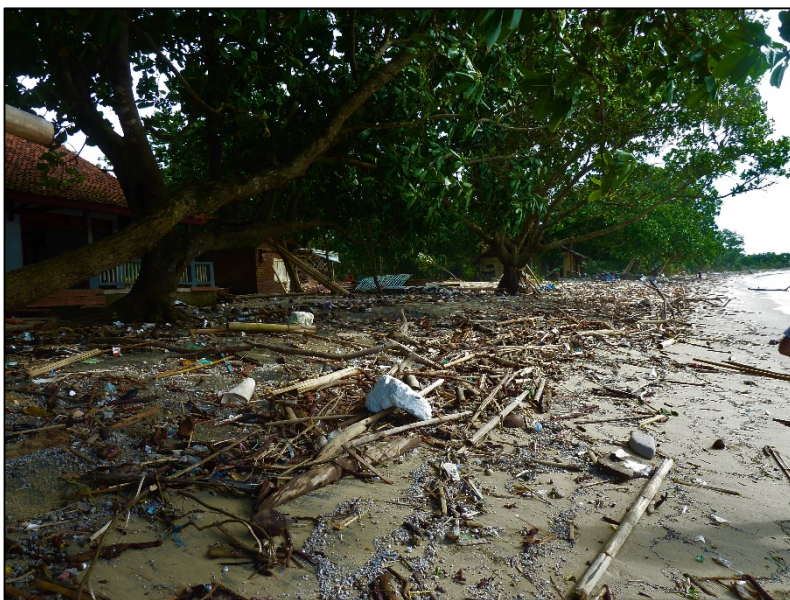
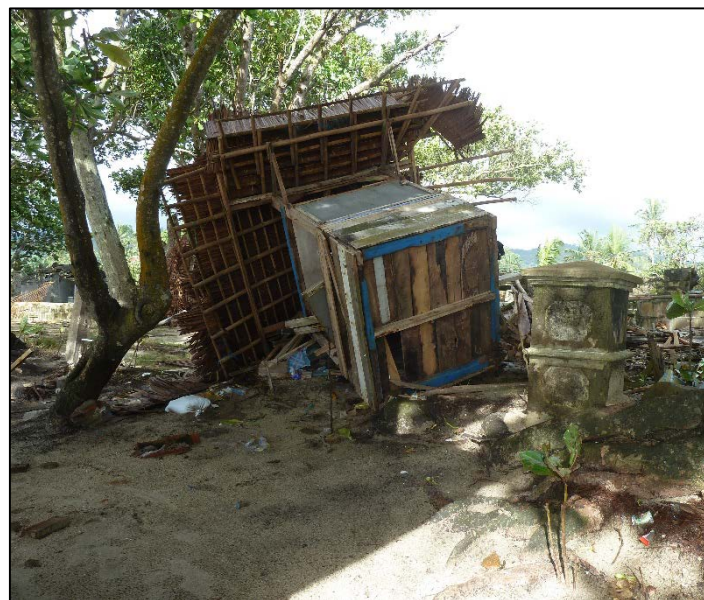
All wooden structures along the beach were washed away by the incoming tsunami waves resulting in destruction

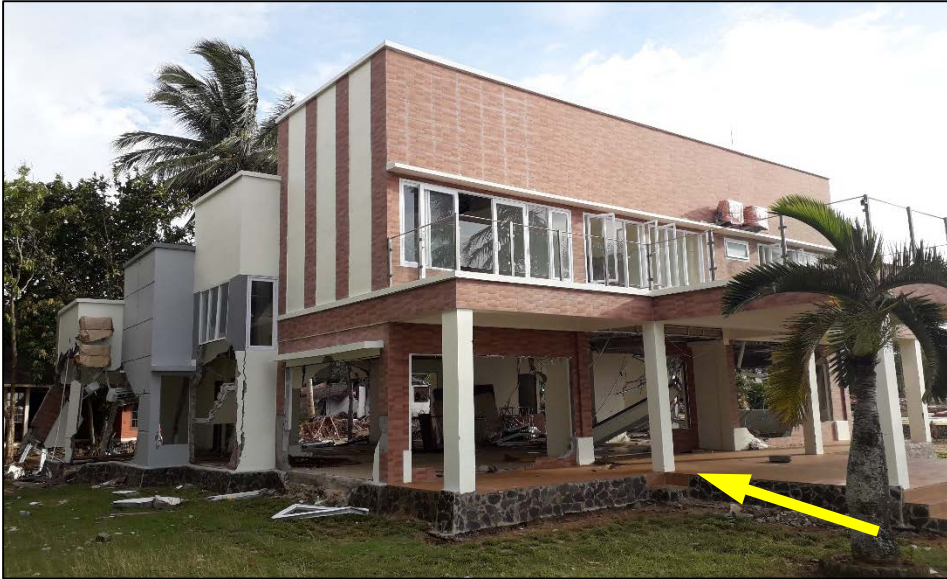
Their infill walls of the ground floor are blown away due to impact with tsunami waves, mobile objects and tsunami debris. Columns of the first floor are damaged due to impact with tsunami waves, mobile objects and tsunami debris. The damage observed in the first floor depends on the height of the tsunami waves. The upper floor of the buildings remained intact.

Arrows indicate the direction of tsunami water flow

The RC structures suffered mainly heavy non-structural damage. Their infill walls of the ground floor were blown away due to the impact with tsunami waves, mobile objects and tsunami debris. Columns of the first floor were damaged due to the aforementioned impact. The damage observed in the first floor depends on the height of the tsunami waves, while the upper floor remained intact. However, many small RC buildings located along the beach front in the heavily tsunami-affected areas were also swept away. The tsunami washed away many of them, leaving only their concrete base and

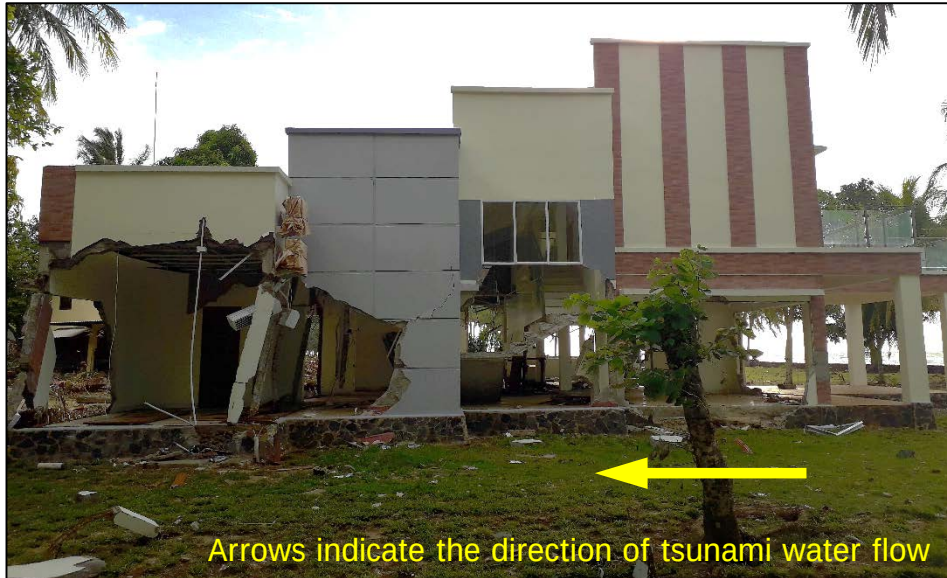
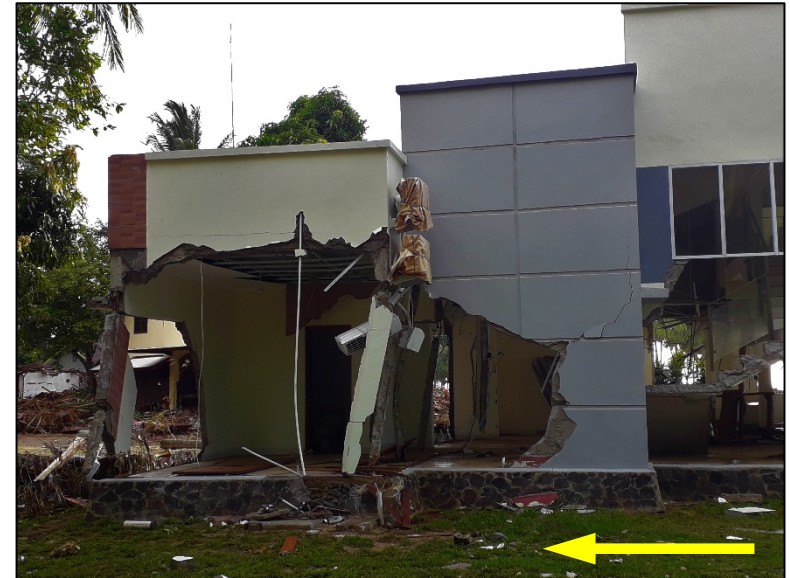
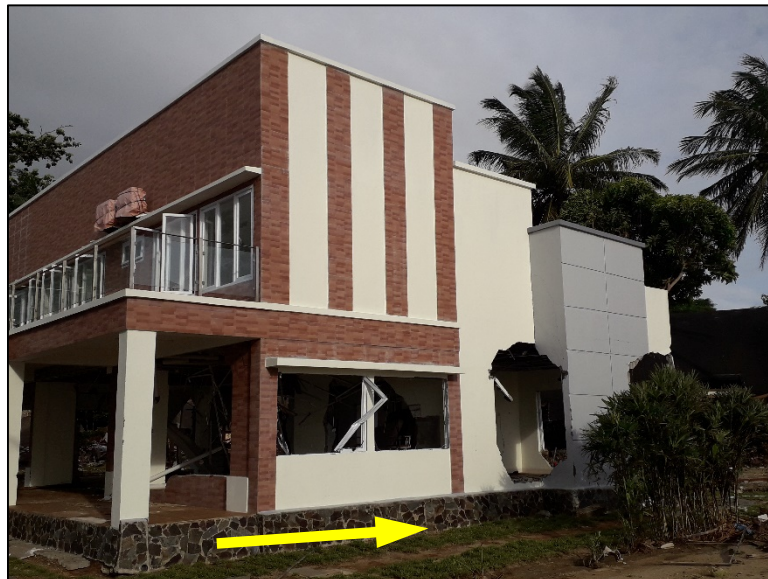
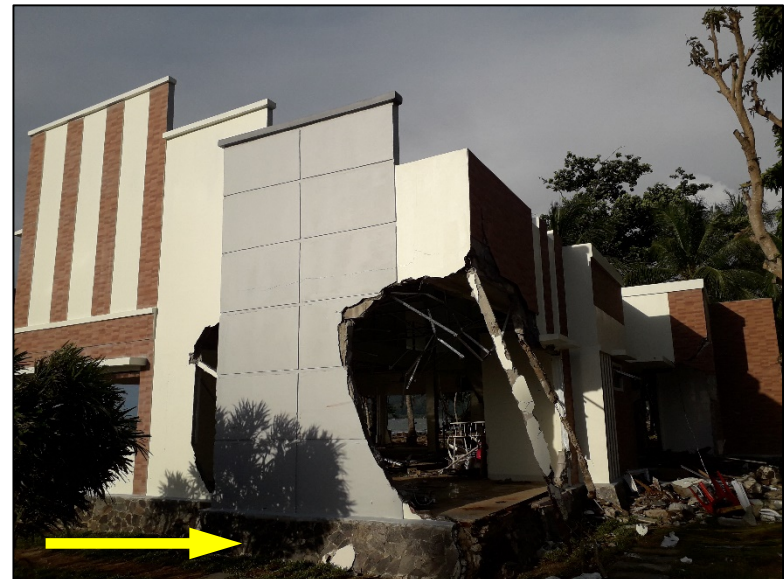
## IMPACT OF THE VOLCANO-TRIGGERED TSUNAMI ON REINFORCED CONCRETE BUILDINGS

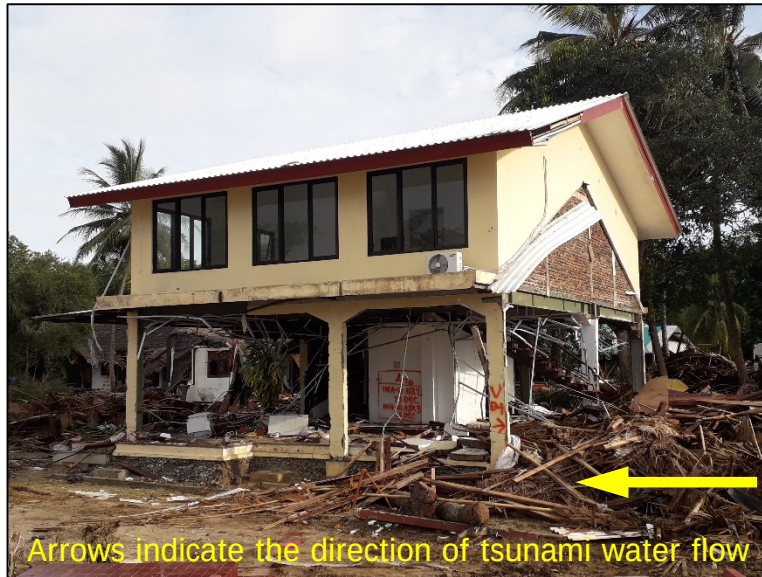
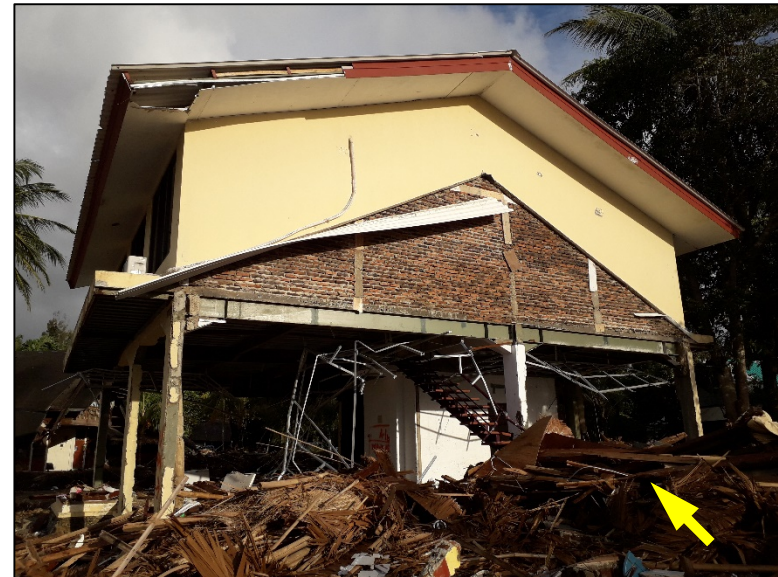
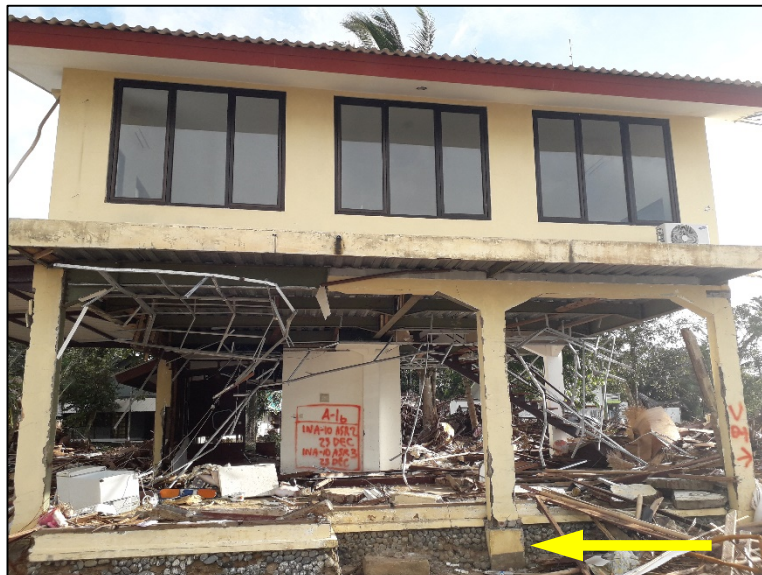
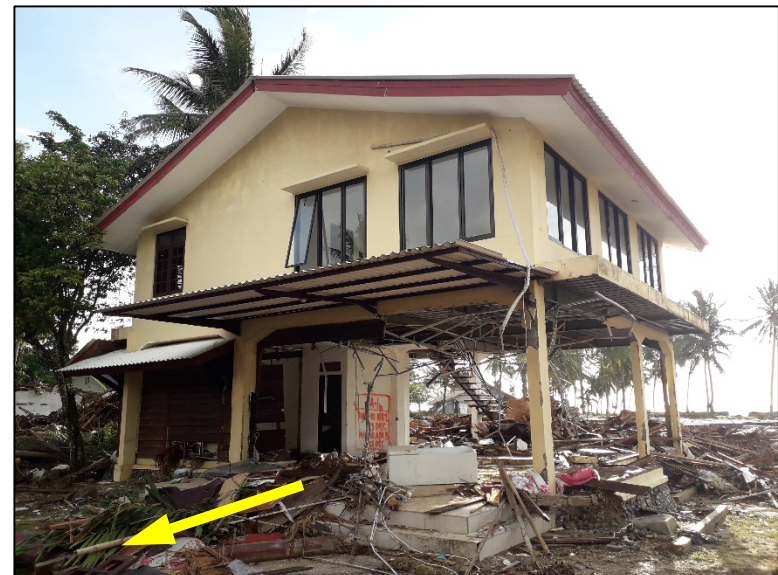
## IMPACT OF THE VOLCANO-TRIGGERED TSUNAMI ON REINFORCED CONCRETE BUILDINGS

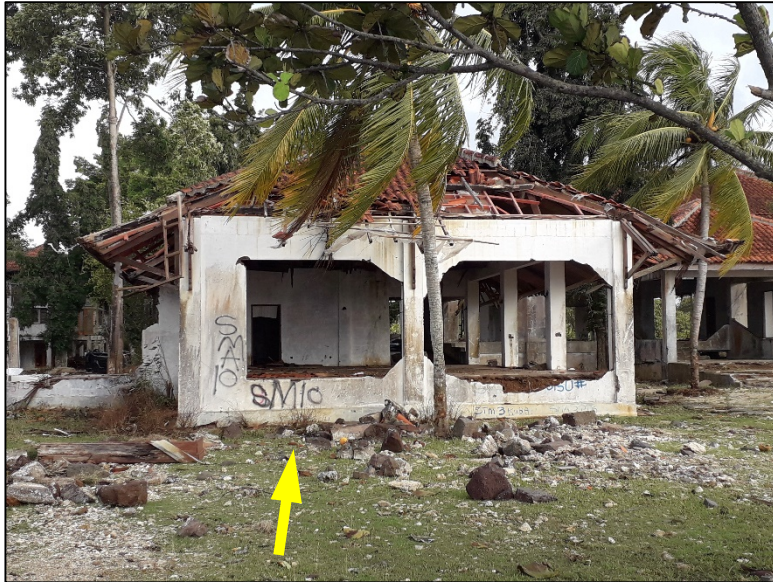
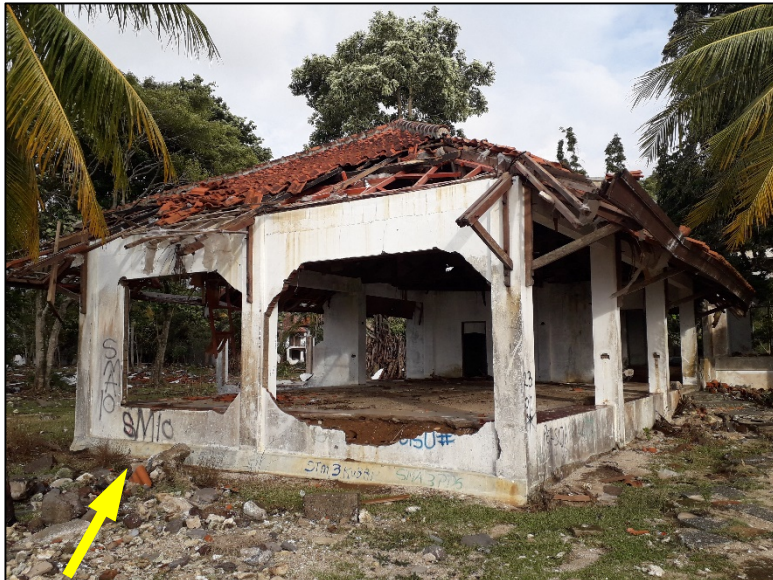
## IMPACT OF THE VOLCANO-TRIGGERED TSUNAMI ON REINFORCED CONCRETE BUILDINGS

Arrows indicate direction of tsunami water flow

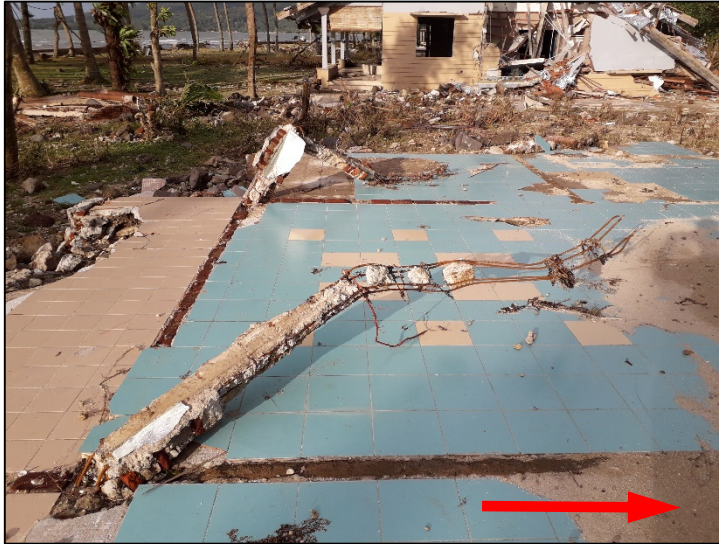
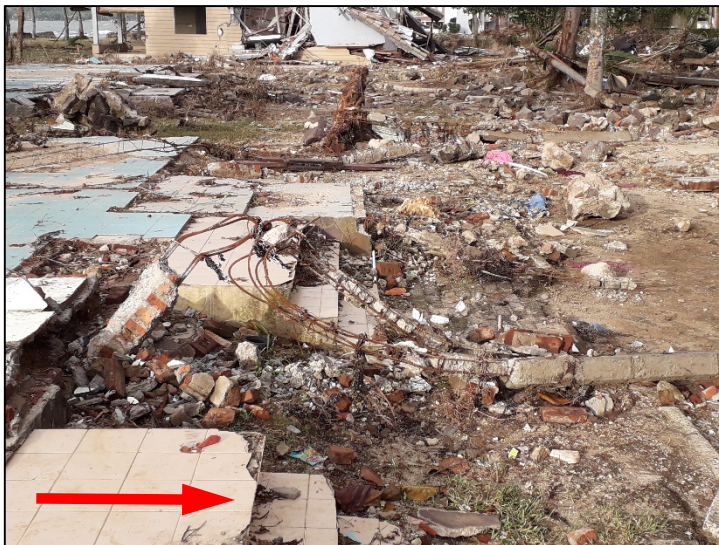
## **IMPACT OF THE VOLCANO-TRIGGERED TSUNAMI ON RC BUILDINGS**

Many sea front RC buildings were also swept away. The tsunami washed away many of them, leaving only their concrete base and buckled the remaining still standing columns.

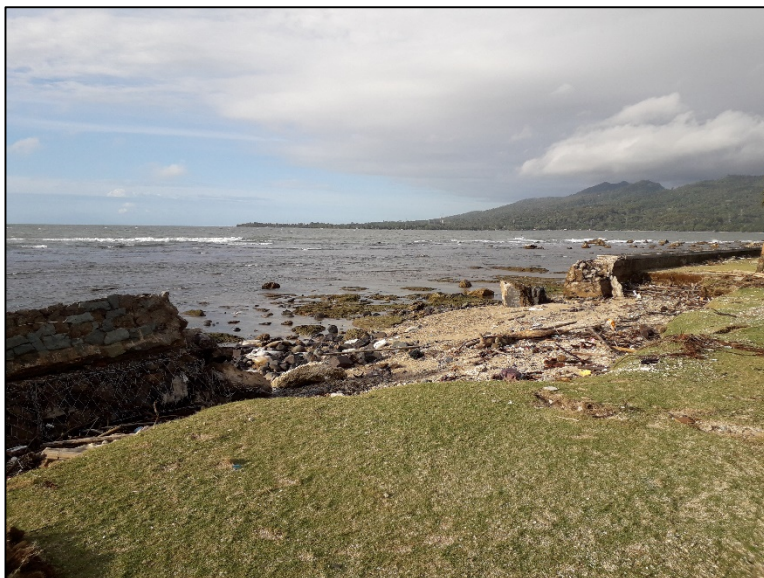
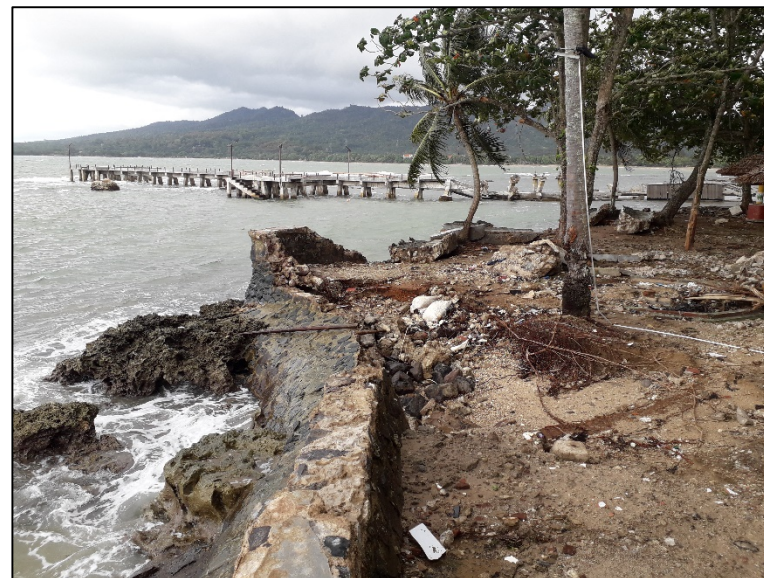
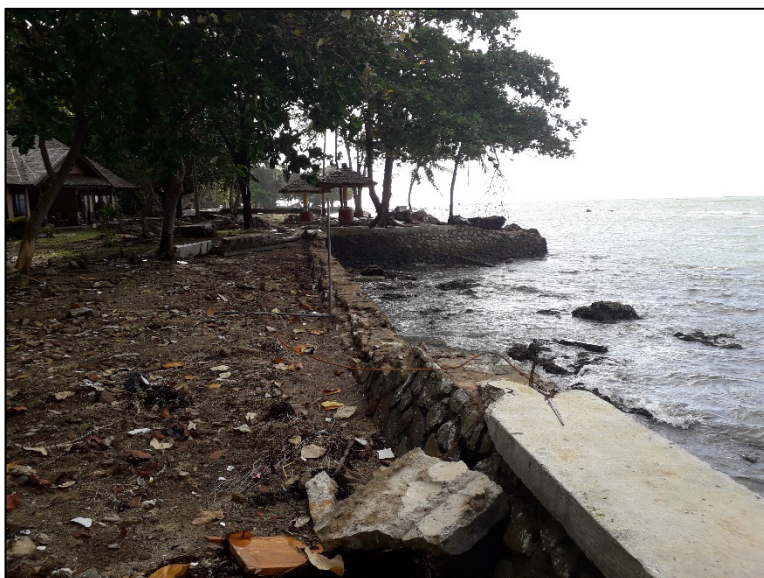
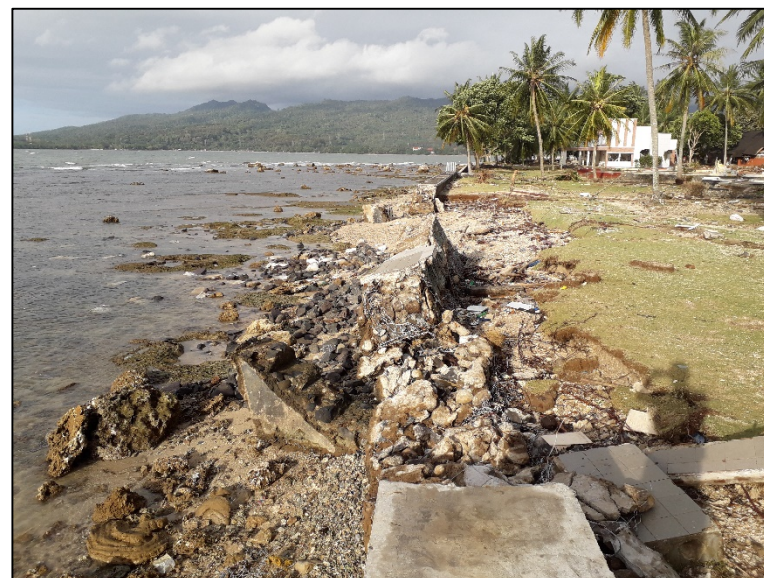
## IMPACT OF THE VOLCANO-TRIGGERED TSUNAMI ON SEA FRONT WALLS

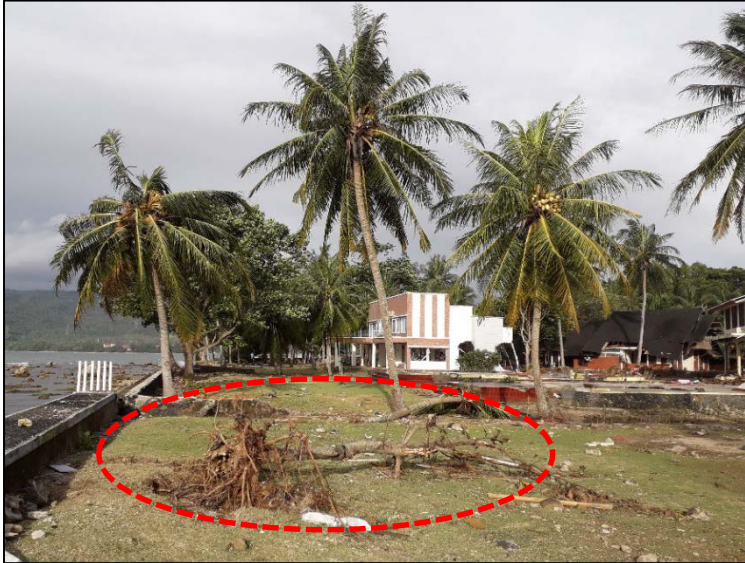
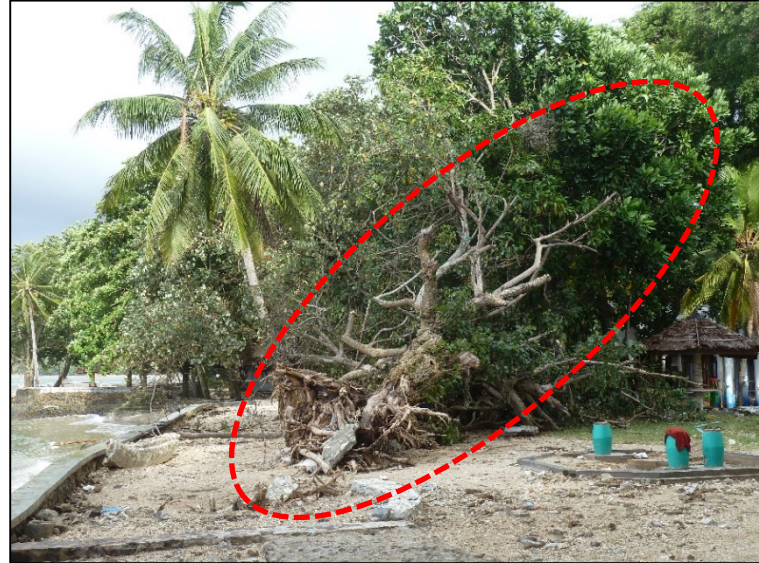
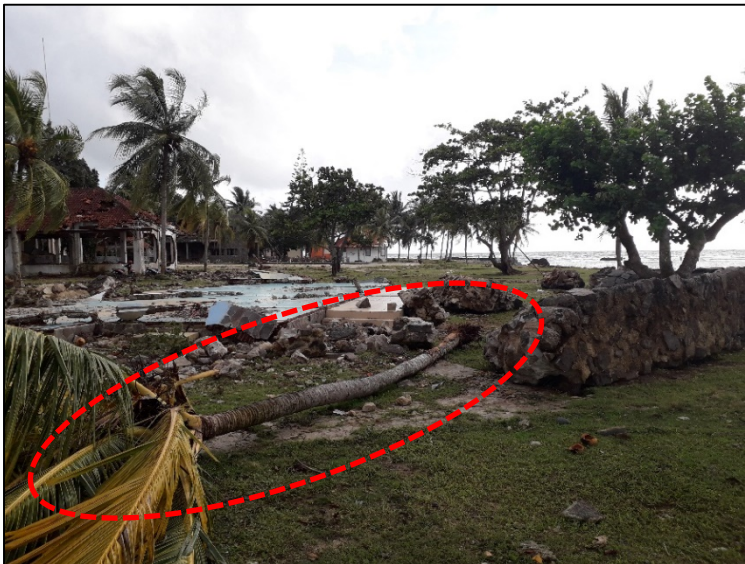
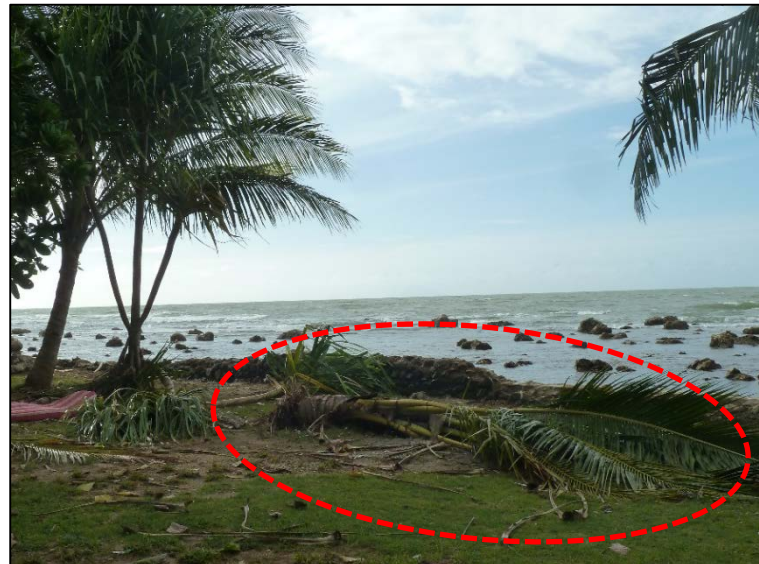
## **IMPACT OF THE VOLCANO-TRIGGERED TSUNAMI ON COASTAL VEGETATION**

Uprooted palm trees due to tsunami on the sand. indicator of the advancing direction of tsunami.

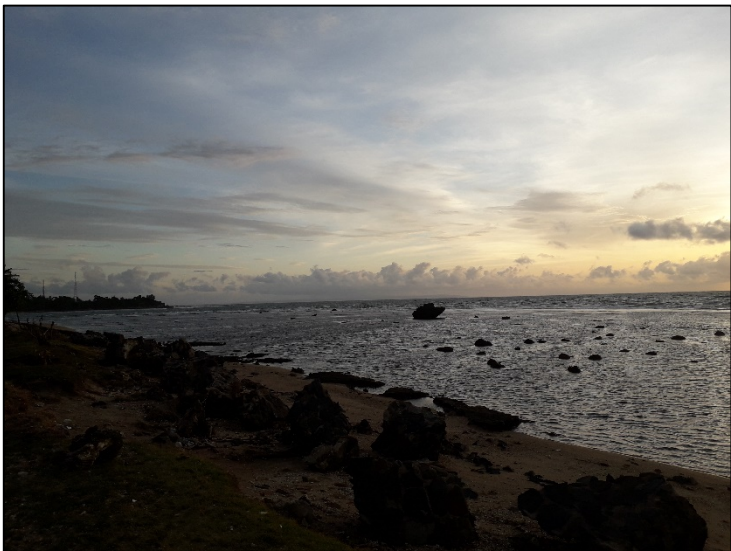
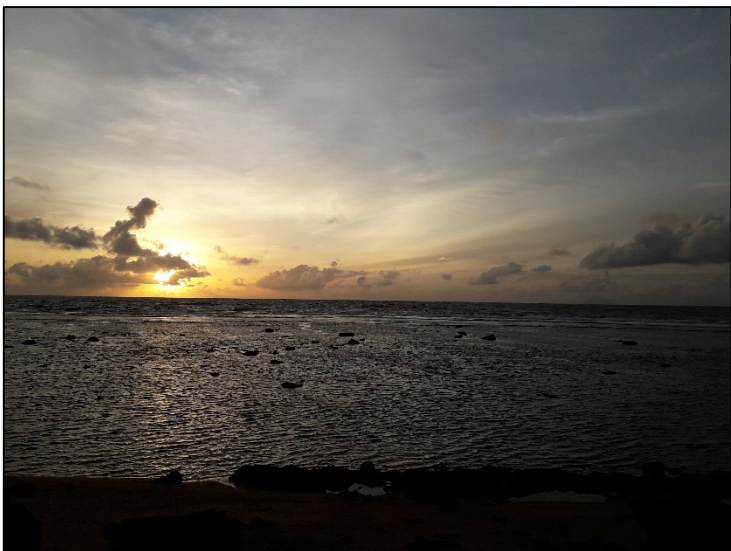
## **IMPACT OF THE VOLCANO-TRIGGERED TSUNAMI ON COASTAL MORPHOLOGY**

Boulders were either detached from and emplaced on shallower parts of the sea bed close to the affected beaches or displaced for a small distance.
