# Newsletter of **Environmental, Disaster, and Crises Management Strategies**

Issue No.12 | December 2018

## **The December 2018 volcano-triggered tsunami in Krakatau complex (Sunda Strait, Indonesia)**

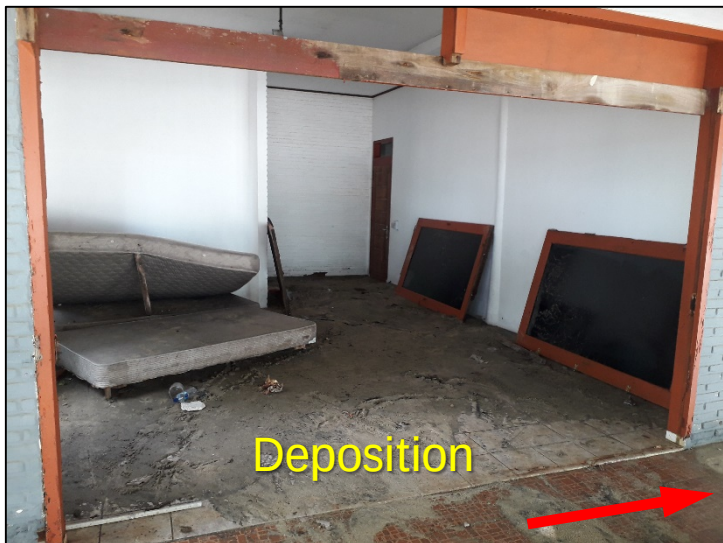
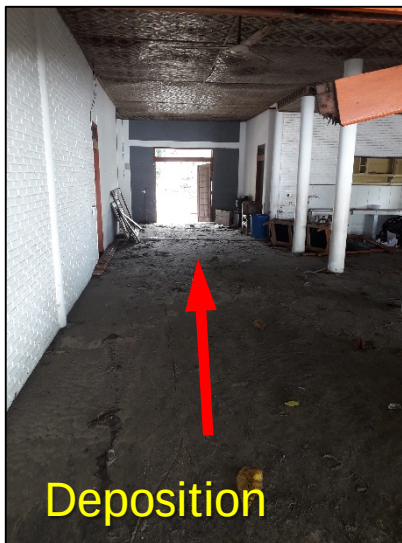
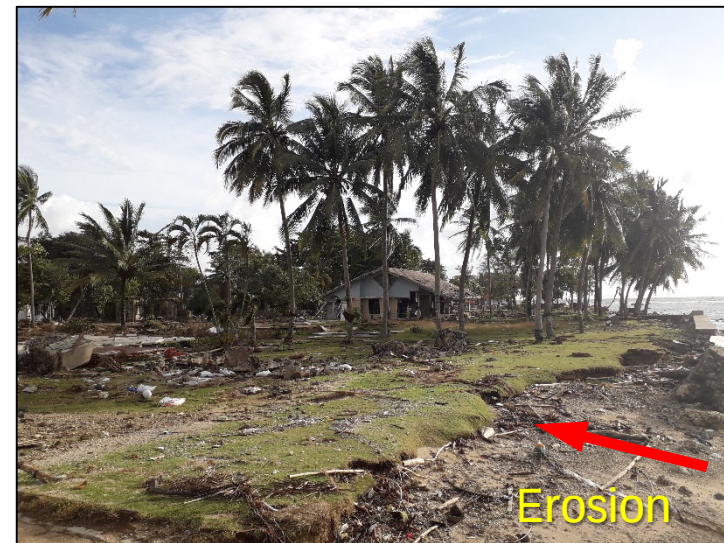
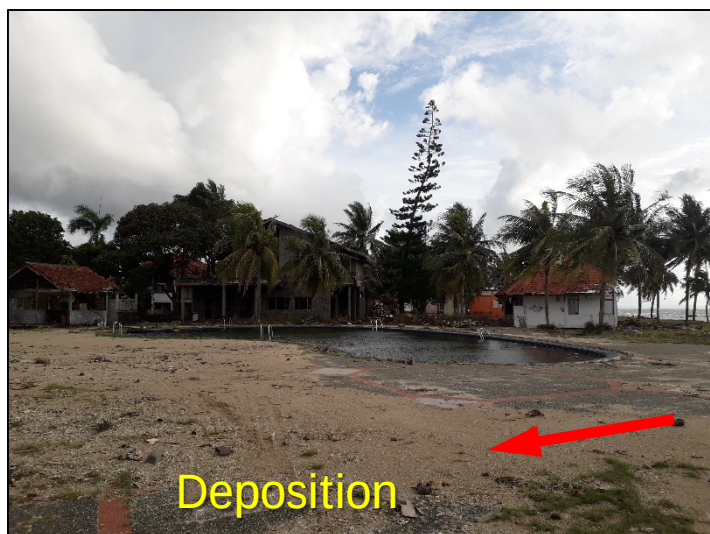
## GEOMORPHOLOGICAL CHANGE AND COASTAL EROSION DUE TO THE TSUNAMI

Beach erosion was induced due the tsunami.

Waves removed beach sand about 1 m vertically and 20 to 30 meters wide and deposited it further inland.

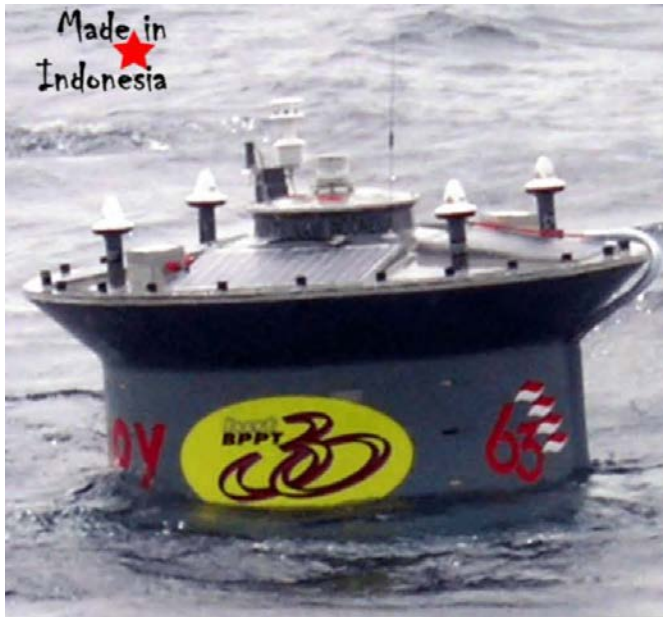
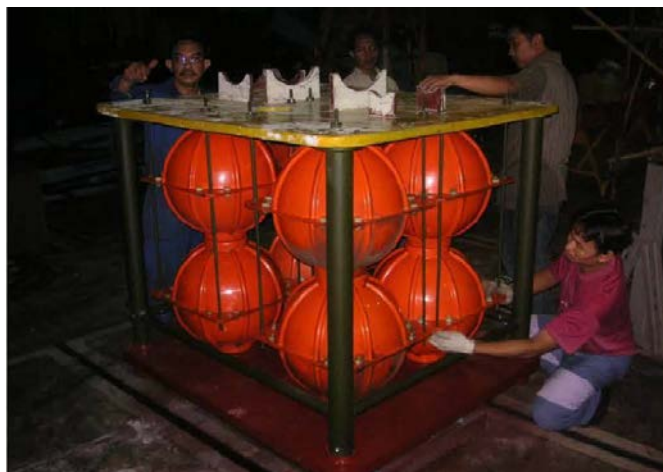
## 2007-2008 BUOY AND OBU DESIGN 2<sup>nd</sup> GENERATION SERIES
